Reference: Route 28 Environmental Assessment Support Services, Supplement 1 -Threatened and Endangered Species Survey

Per your request, Stantec Consulting Services Inc. (Stantec) coordinated surveys for the federally and state endangered dwarf wedgemussel (*Alasmidonta heterodon*) and harperella (*Ptilimnium nodosum*), and the state endangered brook floater (*Alasmidonta varicosa*) on the above-referenced project. Stantec also conducted an assessment of three bridges that occur within the project to determine if bats are utilizing the bridges as day and/or night roosts. The project area consists of three (3) current alternatives, designated as 2A, 2B, and 4, associated with the proposed improvements in the Route 28 corridor between Sudley Road (Business Route 234) in Prince William County and Compton Road (Route 658) in Fairfax County, all located within the Bull Run drainage basin (Figures 1 & 2). The study limits associated with these project corridors were established during the Route 28 Corridor Feasibility Study completed in 2018 in support of the Environmental Assessment (EA) for the project. The following sections discuss the methods and results of each survey.

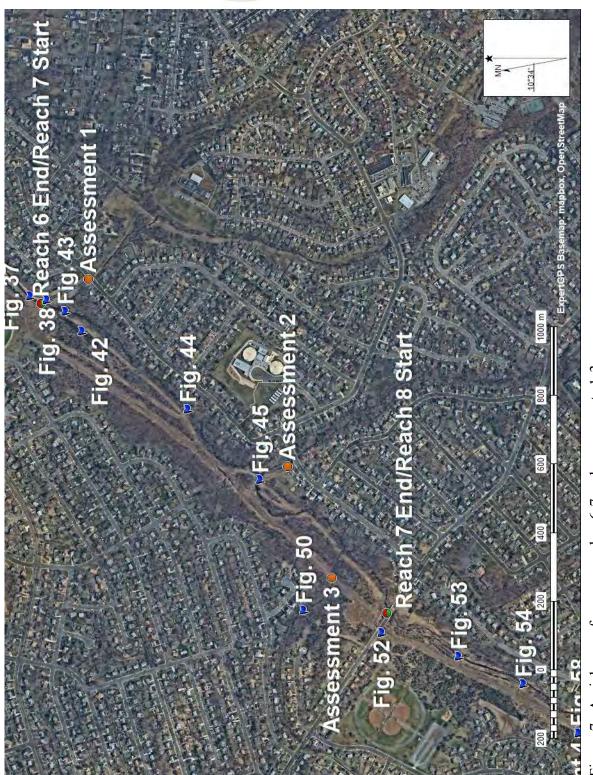
Figure 7. Aerial map of survey reaches 6-7 and assessments 1-3.

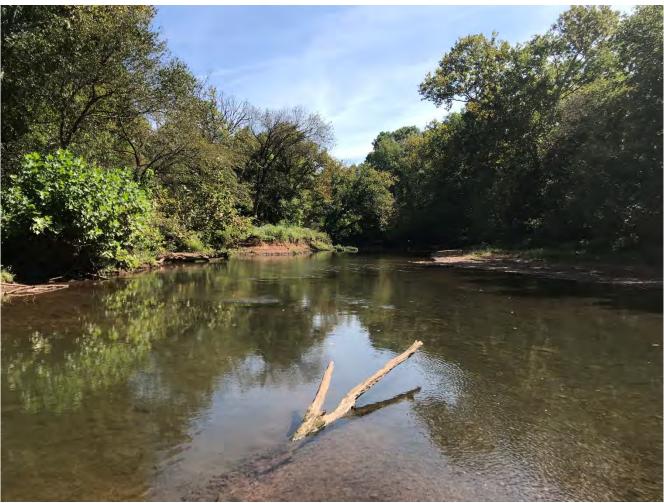
Figure 10. This shallow run habitat downstream of the Virginia Rte 28 was typical for Survey Reach 1. Mussels were scattered throughout this habitat with dead shells on exposed bars.

Stream	Survey Reach	Label		Longitude
Bull Run	1	Downstream Start	38.803671	-77.44459
Bull Run	1	Figure 10: Downstream Route 28	38.803867	-77.44704
Bull Run	1	Figure 12: Upstream Route 28	38.802875	-77.44945
Bull Run	1	Upstream End	38.802393	-77.45039
Bull Run	1	Figure 18: C. fluminea shells on streambed	38.803647	-77.44501
Bull Run	2	Figures 19&20: Campsite and garbage on south bank	38.796386	-77.45759
Bull Run	2	Downstream Start	38.796109	-77.45321
Bull Run	2	Figure 21: Unstable gravel shoal	38.796036	-77.45407
Bull Run	2	Downstream Boundary Bed	38.795843	-77.45671
Bull Run	2	Figure 22&23: Upstream Boundary Bed	38.795897	-77.45715
Bull Run	2,4	Figure 30: Photo at Reach 2&4 boundary	38.797657	-77.45890
UOSA Tailwater	3	Figure 26: Downstream Start, Mouth	38.797246	-77.45743
UOSA Tailwater	3	Figure 27: <i>C. fluminea</i> streambed material	38.798027	-77.45682
UOSA Tailwater	3	Figure 29: Plungepool below 616	38.800088	-77.45532

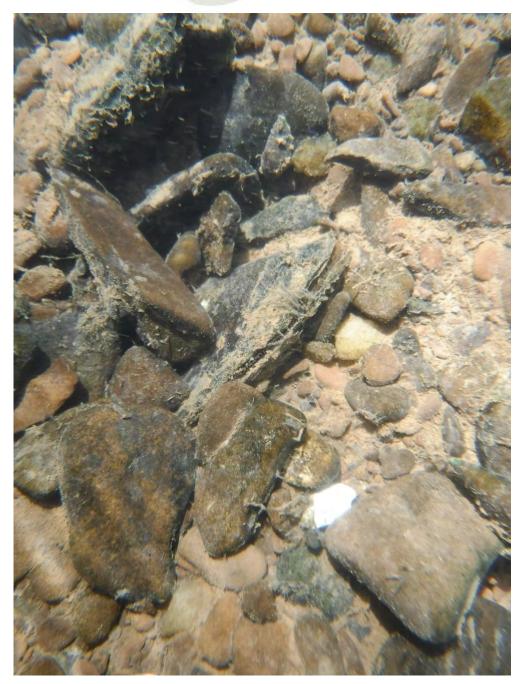
Figure 11. Typical streambed inhabited by mussel downstream of the Rte 28 bridge in Survey Reach 1

30% pool habitat. It had a diverse streambed that was 5% exposed bedrock, 10% boulder, 20% cobble, 25% gravel, 30% sand, and 10% silt. Most of the streambed was stable and good habitat for mussels (Figure 11). Except in the rapid, larger particles tended to be moderately to heavily embedded by small particles, leaving little habitat for aquatic insects. Downstream of the bridge, most habitats were less than 0.5 m deep, with a maximum depth of 1.6 m. Upstream of a boulder rapid at the bridge, there was pool habitat, mostly greater than 1 m deep (Figure 12). Large woody debris was common throughout the surveyed reach, contributing to habitat complexity.

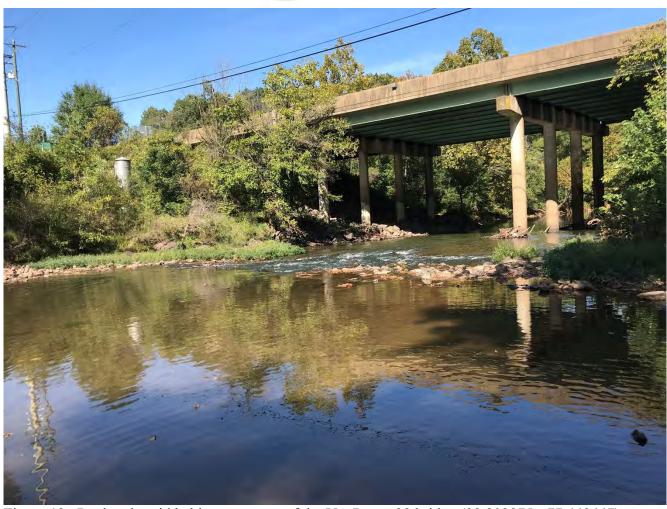
Figure 12. Pool and rapid habitat upstream of the VA Route 28 bridge (38.802875, -77.449447).

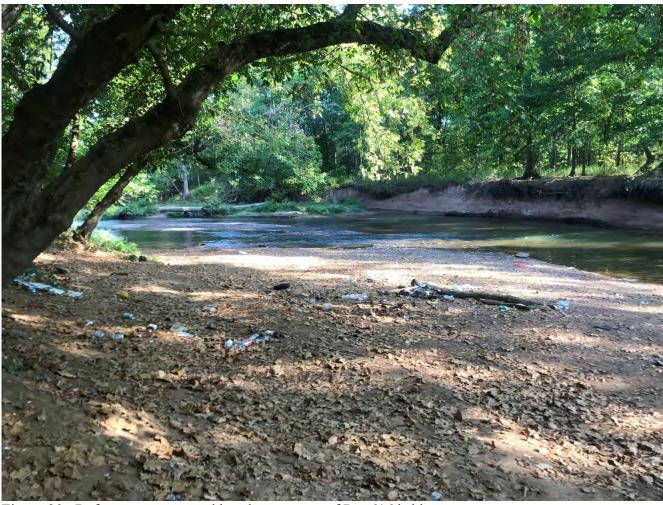
Figure 20. Refuse on an exposed bar downstream of Rte 616 bridge.

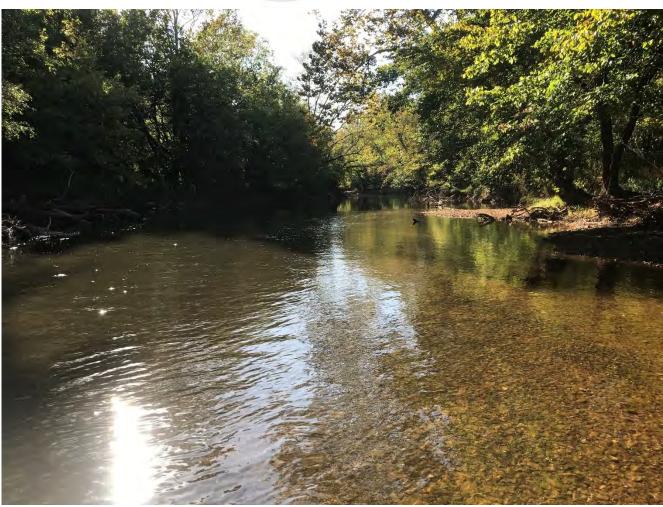
Figure 21. Unstable gravel shoal approximately 400 m downstream of the Rte 616 bridge. We pictured typical habitat for Reach 2.

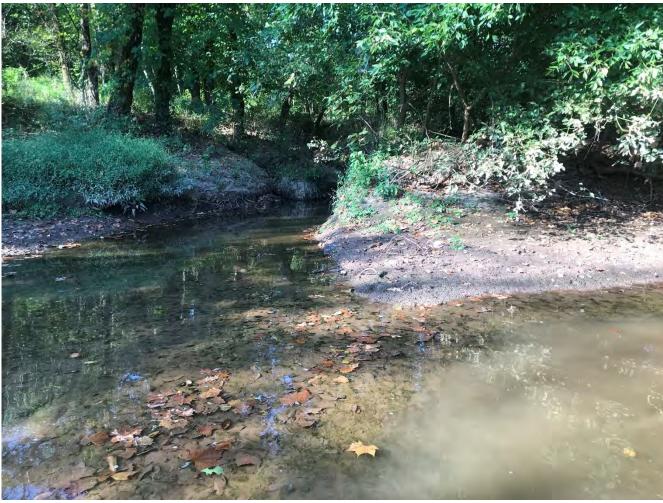
Figure 22. This depositional area was the only mussel bed we detected in this study.

The UOSA impoundment and tailwater appeared to be an important ecological driver in Bull Run. The most important habitat for native mussels we observed in this study was a depositional area where flows from the tailwater settled. This tailwater provided food and warmth to support many native mussels. Coincidentally, this habitat also supported the highest densities of *C. fluminea* that we have ever observed in Virginia. We also documented *C. c. malleata* there. Bull Run was 3°C warmer downstream of the tailwater than upstream. Mussels grew faster downstream of the tailwater and reached a greater size (compare Figures 24 and 34). Upstream of the tailwater, *C. fluminea* were less dense, by at least an order of magnitude, and *C. c. malleata* absent.

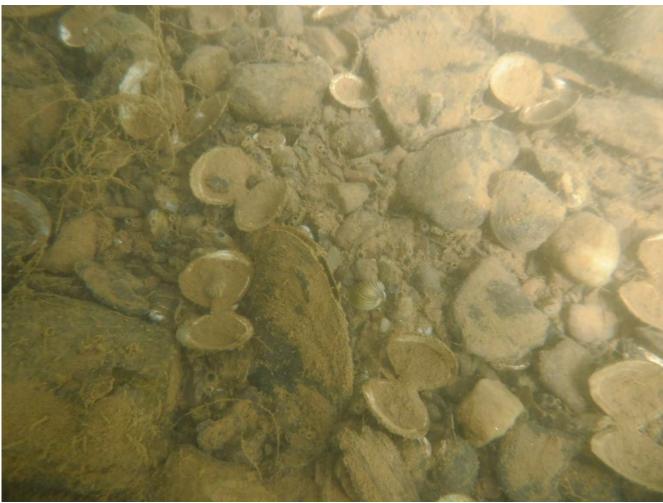
Figure 23. Live *C. fluminea* and shell made up much of the stream bed in the mussel bed we documented in Survey Reach 2. This underwater photograph was taken at the same location shown in Figure 22. A live *E. complanata* was pictured center.

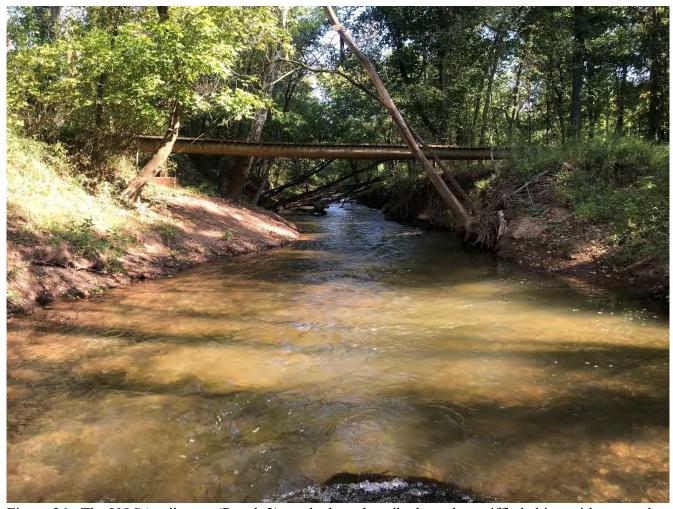
Figure 26. The UOSA tailwater (Reach 3) can be best described as a long riffle habitat with a gravel dominated streambed, as pictured at its mouth.

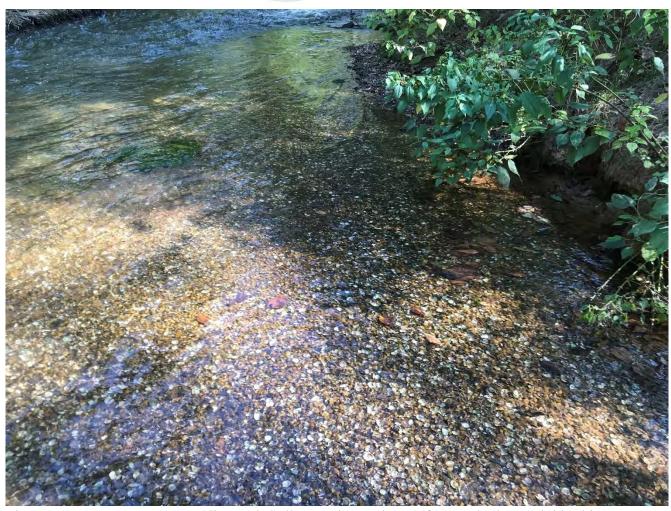
Figure 27. *Corbicula fluminea* live and shell were the top layer of streambed material in this depositional area of the UOSA tailwater (Reach 3; 38.798027, -77.456815).

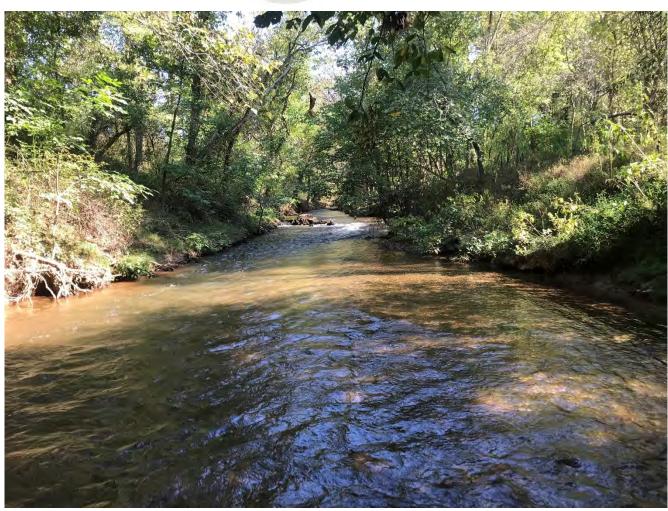
Figure 28. Typical habit in the UOSA tailwater (Reach 3).

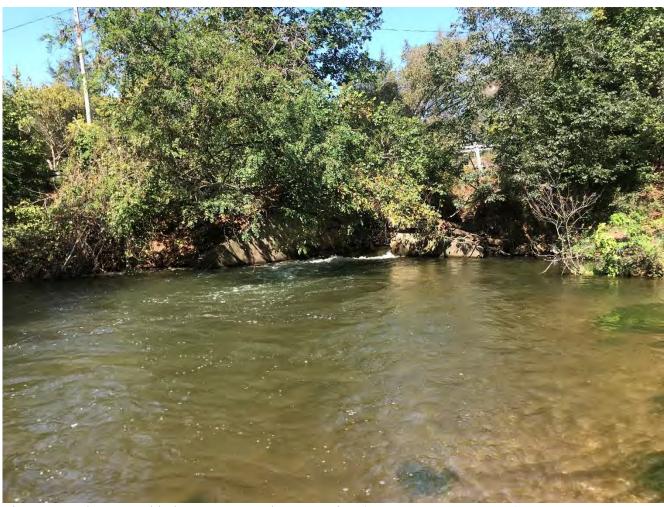
Figure 29. Plunge pool below Rte 616 culvert crossing (38.800088, -77.455316).

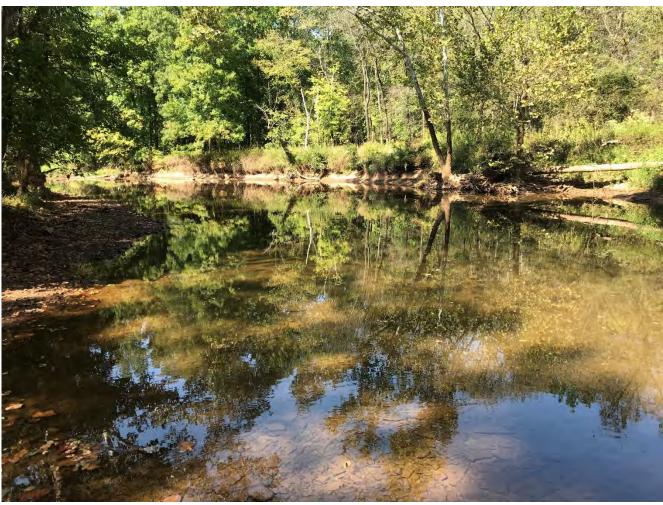
Figure 30. Pool habitat in at the boundary of Reach 2 and 4 (38.797657, -77.458904). Habitat pictured here was representative of 200 m long area upsteam of the Rte 616 bridge.

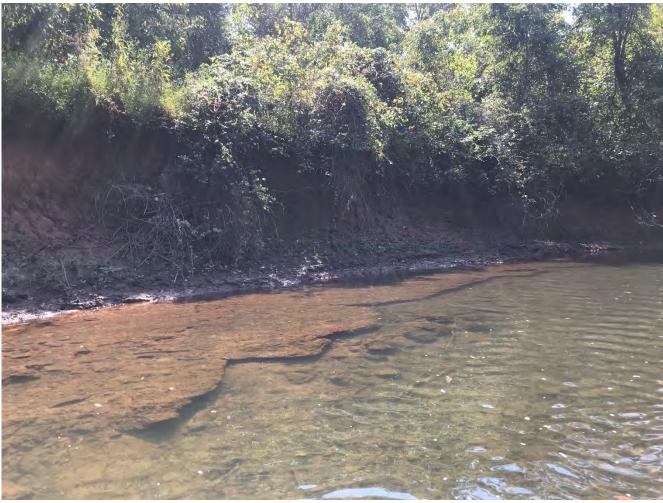
Figure 31. Unstable bank in Bull Run, Reach 4 (38.795728, -77.461206). Some slab rock that had broken off the bed ledge can be seen in photograph center. These slab rocks were common in Reach 4 downstream of Cub Run.

UOSA Tailwater	3	Upstream End	38.800991	-77.45624
Bull Run	4	Downstream Start	38.797657	-77.4589
Bull Run	4	Figure 31: Unstable bank	38.795728	-77.46121
Bull Run	4	First riffle upstream of 616	38.79554	-77.46223
Bull Run	4	Figure 32: Shallow habitat	38.796503	-77.46528
Bull Run	4	Figure 33: Pointbars, habitat upstream of Cub Run	38.796543	-77.46663
Bull Run/Cub Run	4	Mouth of Cub and upstream riffle	38.796612	-77.46597
Cub Run	5	Figure 35: 100 m upstream of mouth	38.797578	-77.46551
Bull Run	4	100 m upstream of Flat Branch	38.795719	-77.47067
Flat Branch	6	Figure 36: Downstream start, mouth	38.795876	-77.46941
Flat Branch	6	Figure 37: Shad	38.791317	-77.47631
Flat Branch	6	Figure 38: Boulder dam	38.790847	-77.47657
Flat Branch	6	Upstream End	38.790749	-77.47668
Flat Branch	6	Assessment 1, Figure 39	38.790876	-77.47643
Flat Branch	6	Assessment 1, Figure 40	38.789878	-77.47585

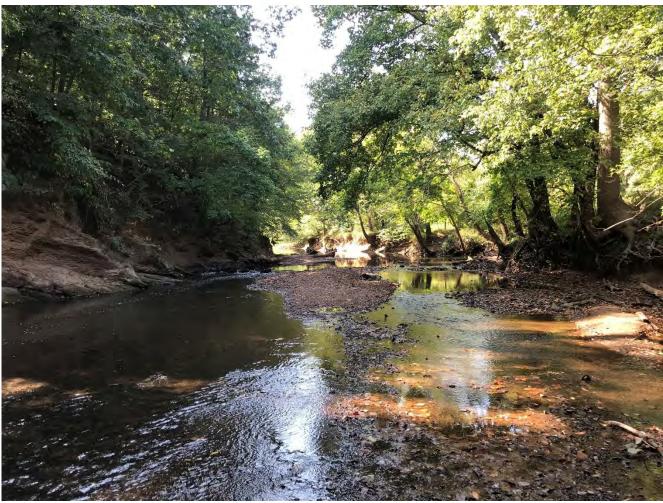
Figure 32. Shallower habits downstream of Cub Run in Reach 4 (38.796503, -77.465275). Exposed streambed and bank conditions pictured here were typical for Reach 4 downstream of Cub Run.

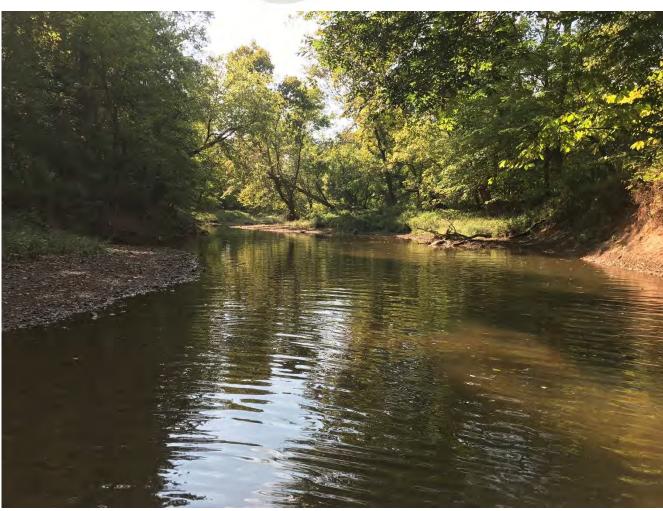
Figure 33. Reach 4 upstream of Cub Run was a narrower meandering stream within a larger channel that had point bars and riffles at regular frequencies (38.796543, -77.466628).

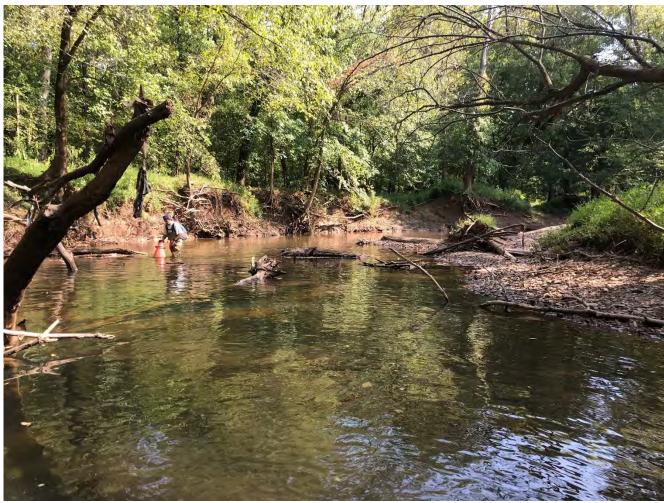
Figure 35. Cub Run approximately 100 m upstream from its mouth was littered with large woody debris and was cut at least 2.5 m into the Bull Run floodplain (38.797578, -77.465508).

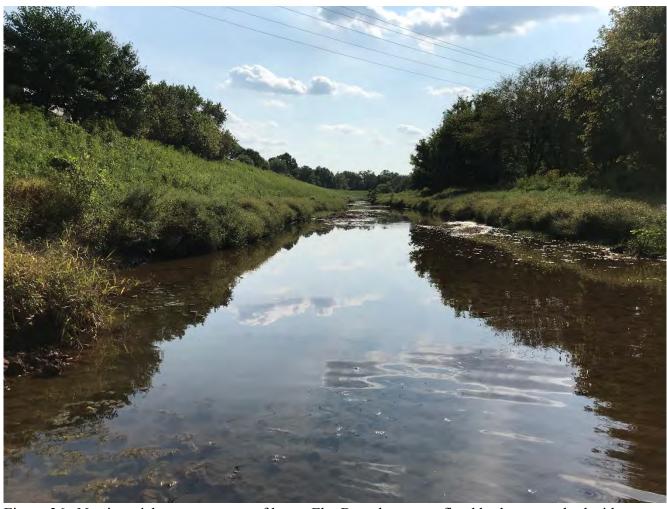
Figure 36. Nutrient rich, warm waters of lower Flat Branch was confined by levees on both sides (38.795876, -77.469409).

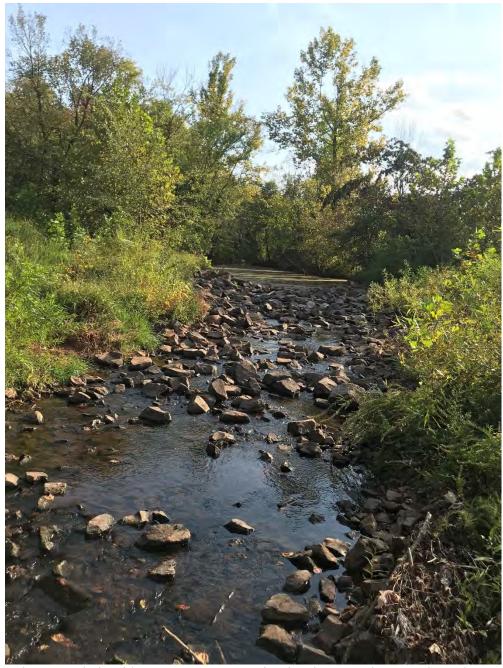
Figure 38. Anthropogenic boulders atop sewer crossing in Flat Branch approximately 850 m upstream from the mouth (38.790847, -77.476570). The pool formed by the rock dam can be seen in the background.

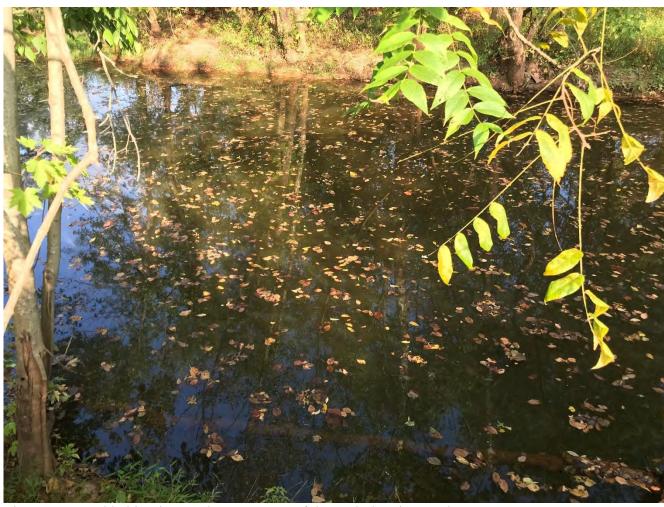
Figure 43. Pool habitat in Reach 7 upstream of the rock dam in Reach 7.

Stream	Survey Reach	Label	Lattitude	Longitude
Flat Branch	7	Figure 42: Western isolated channel	38.789958	-77.47749
Flat Branch	7	Figure 43: Pool habitat	38.790392	-77.47683
Flat Branch	7	Figure 44: Large Woody Debris and Refuse in Flat Branch	38.787177	-77.48011
Flat Branch	7	Figure 45: Run habitat with gravel bed	38.785287	-77.48247
Flat Branch	7	Figure 46: Assessment 2	38.784578	-77.48203
Flat Branch	7	Figure 47: Assessment 2, Upstream of Lomond Drive	38.784242	-77.48161
Flat Branch	7	Assessment 3 downstream	38.783108	-77.48486
Flat Branch	7	Figure 49: Assessment 3	38.783522	-77.48618
Flat Branch	7	Figure 50: Assessment 3 upstream	38.784144	-77.48683
Flat Branch	7	Figure 51: Habitat downstream of Lomond Drive Bridge	38.782014	-77.48644
Flat Branch	7	Upstream End	38.795876	-77.46941
Flat Branch	8	Figure 52: Reach 8 corridor	38.782100	-77.48758
Flat Branch	8	Figure 53: Beaver dam	38.780069	-77.48838
Flat Branch	8	Figure 54: Excellent mussel habitat	38.778382	-77.48932

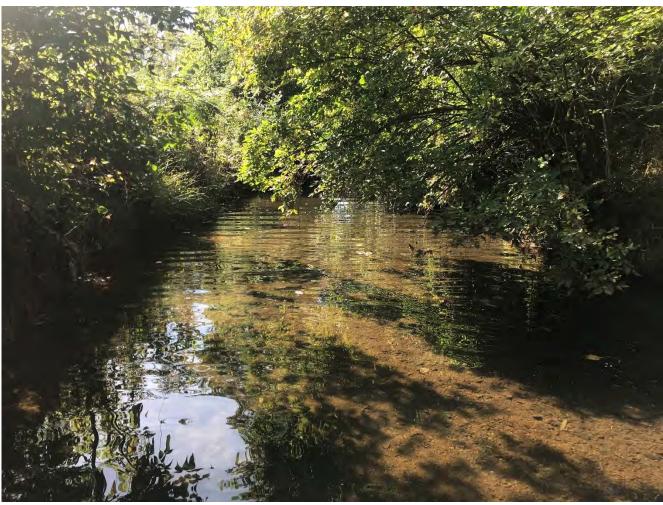
Figure 45. Some shallow runs with gravel streambeds in Flat Branch provided potential habitat for mussels. None were detected (38.785287, -77.482472).

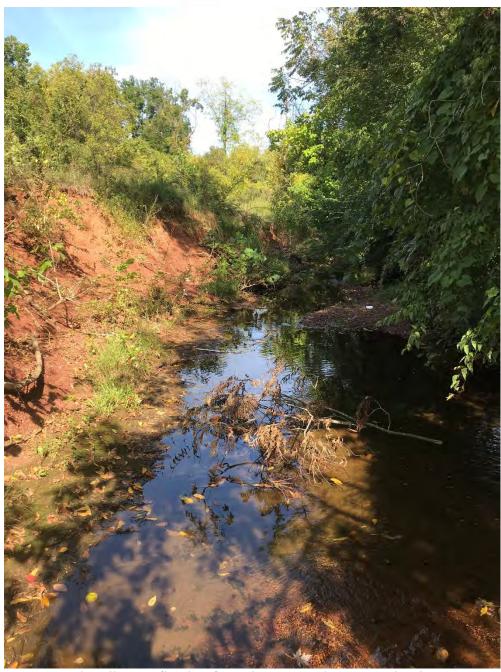
Figure 46. We assessed a tributary flowing from the east, under Lomond Drive (Assessment 2). We found no evidence of mussels and the stream seemed extremely flashy (38.784578, -77.482033).

We surveyed the downstream reach of this unnamed stream and assessed it from Lomond Drive. The upstream reach was wetted and 1-2 m wide. Its stream bottom was mostly bedrock. The stream was incised 2m below lawns (Figure 46 and 47). We found no evidence to suggest mussels inhabited the stream. This stream may have once drained a wetland and we found evidence that neighborhoods to the east may have once been a wetland (Figure 48).

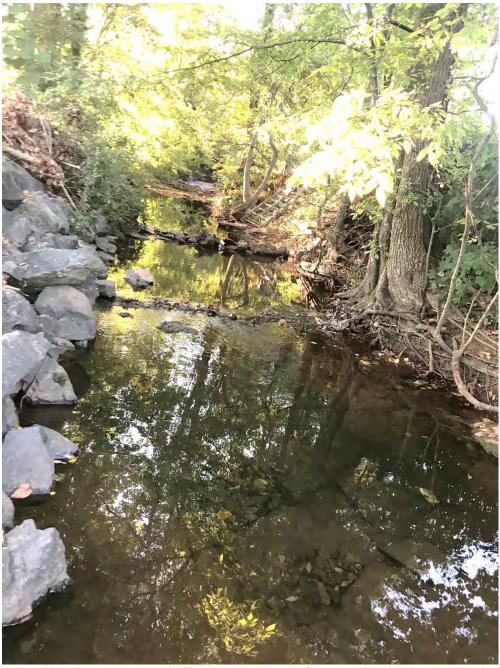
Figure 47. Habitat in an unnamed tributary upstream of Lomond Drive had a mostly bedrock streambed (38.784242, -77.481606).

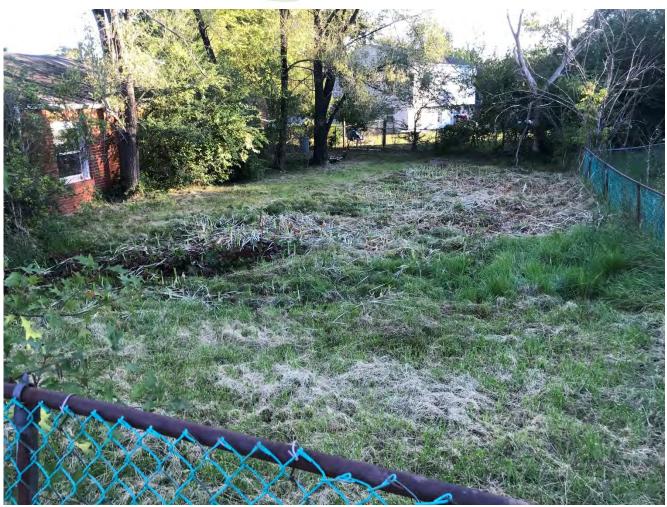
Figure 48. This lawn near assessment 2 was wetland (38.783622, -77.482269), this and other features suggested areas around Flat Branch had once been low lying wetlands.

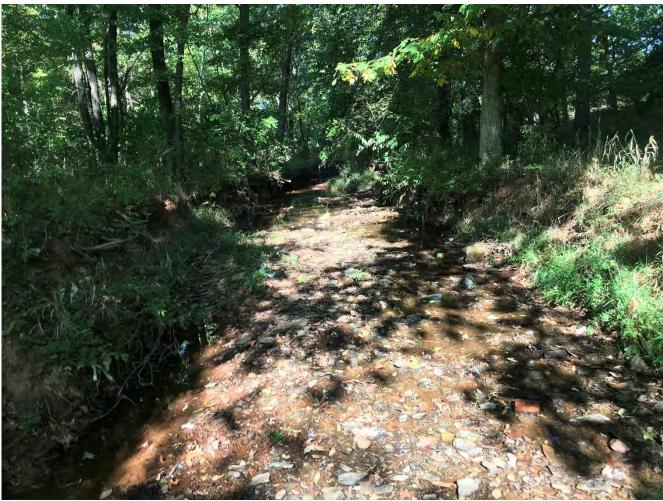
Figure 49. Assessment Reach 3 had at most 5 cm of flow over cobble and gravel just upstream of the utility corridor (38.783522, -77.486183).

We surveyed an unnamed tributary to Flat Branch that flowed from the west, entering Flat Branch approximately 250 m downstream of the Lomond Drive Bridge. This stream was wetted and 1-2 m wide. This stream had some streambed habitat for mussels and supported fish (Figures 49 and 50). We surveyed the stream up to where it bordered lawns of a residential neighborhood, finding no evidence of mussels.

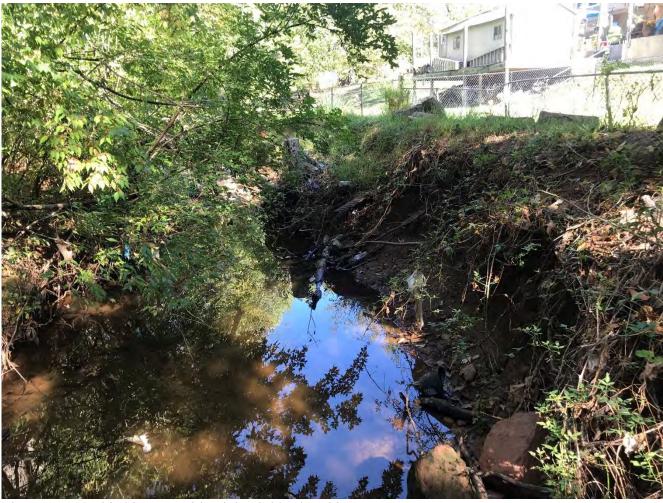
Figure 50. Pool habitat at residential neighborhood in Assessment 3.

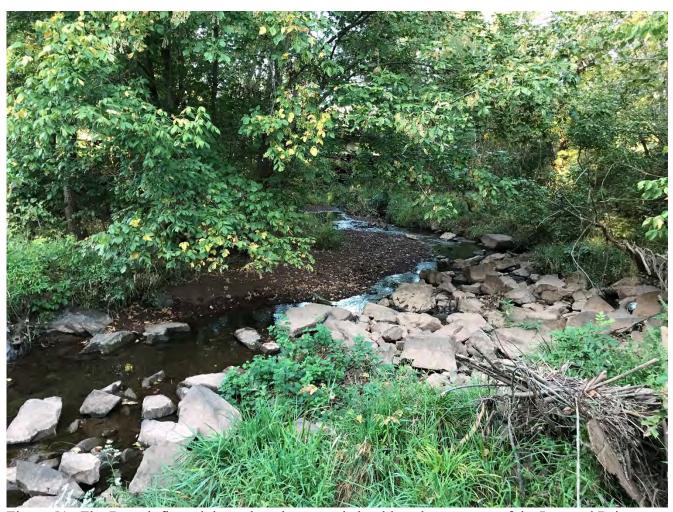
Figure 51. Flat Branch flowed through anthropogenic boulders downstream of the Lomond Drive Bridge (38.782014, -77.486442).

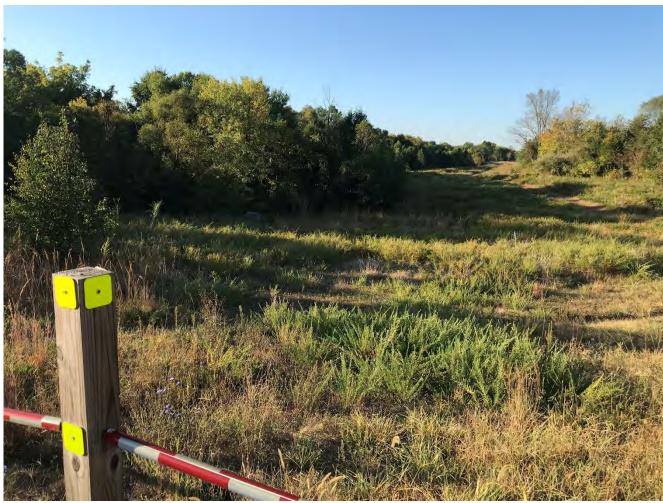
Figure 52. Utility corridor through which Reach 8 of Flat Branch flowed (38.782100, -77.487581). Flat Branch was shaded by the tree line pictured left. Flat Branch Reach 8 has been allowed to rework itself in this floodway, unlike Reach 6 where it was confined by levees and straightened.

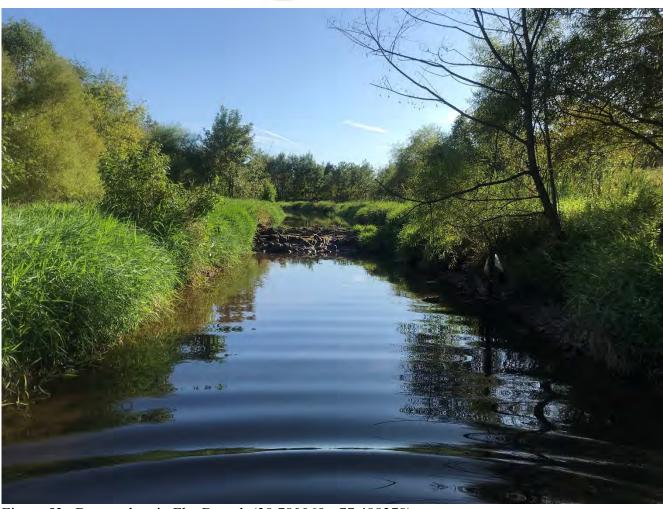
Figure 53. Beaver dam in Flat Branch (38.780069, -77.488378).

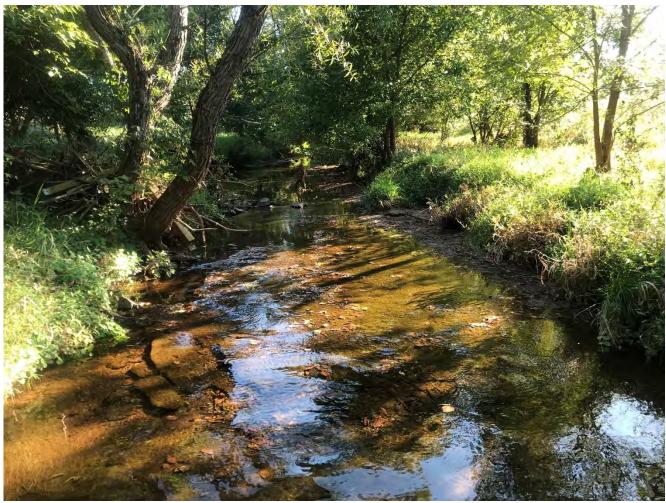
Figure 54. Flat Branch had probably re-worked a fluvial channel with at least 2 meandering channels through a corridor between residential areas (38.778382, -77.489316). Banks were low and the streambed provided excellent habitat for mussels.

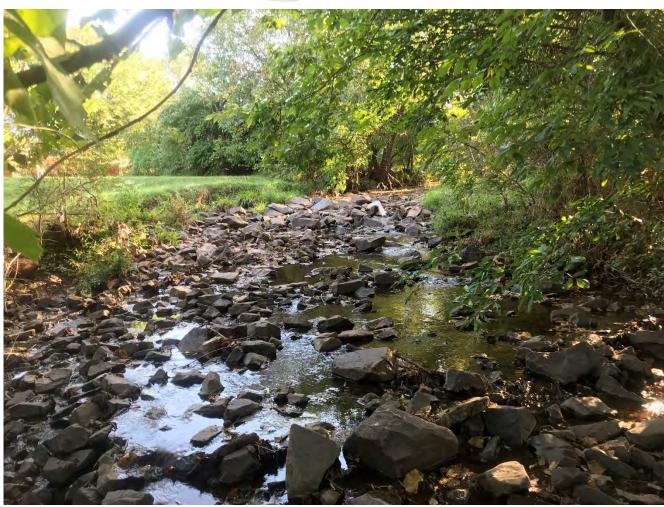
Figure 55. Anthropogenic boulders in a widened section of Flat Branch in Reach 8.

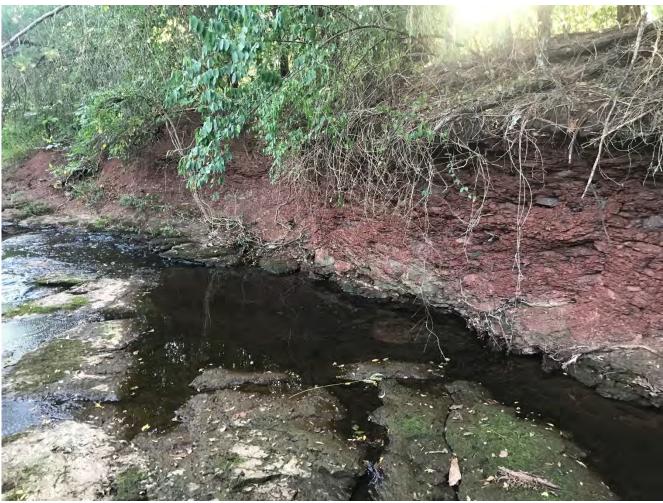
Figure 56. Banks like the one pictured here had provided much of the streambed. This specific location provided no habitat for mussels as it was exposed bedrock (38.771767, -77.493514).

Flat Branch	8	Figure 56: Erroding bank	38.771767	-77.49351
Flat Branch	8	Figure 57: Pool habitat downstream of Rte 234 crossing	38.770697	-77.49426
Flat Branch	8	Assessment 4 upstream	38.776769	-77.49168
Flat Branch	8	Figure 58: Assessment 4	38.776931	-77.49095
Flat Branch	8	Upstream End Reach 8	38.769083	-77.49492

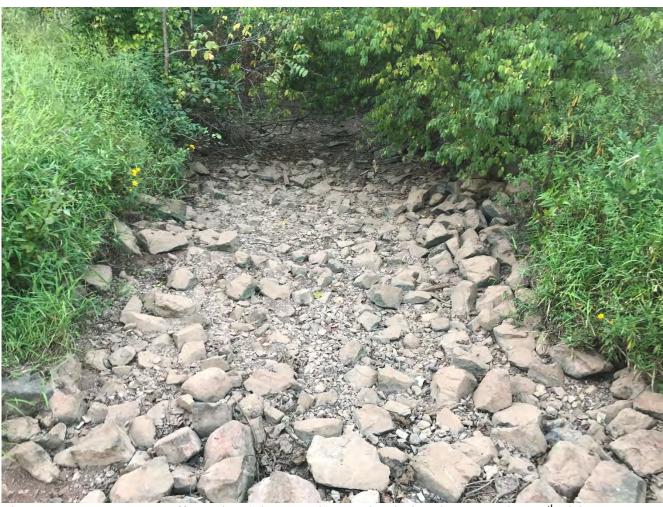
Figure 58. Assessment 4 off Reach 8 (Flat Branch) was dry during the September 19th visit (38.776931, -77.490953).

We assessed one stream entering from the west (Assessment 4) which was mostly dry, providing no habitat for mussels (Figure 58).

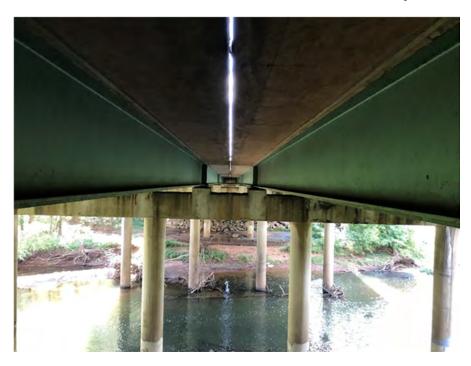
Photo 1: Bridge 1. View of expansion joint between lanes of Route 28 crossing Bull Run. Staining on piers appears to be due to runoff from road.

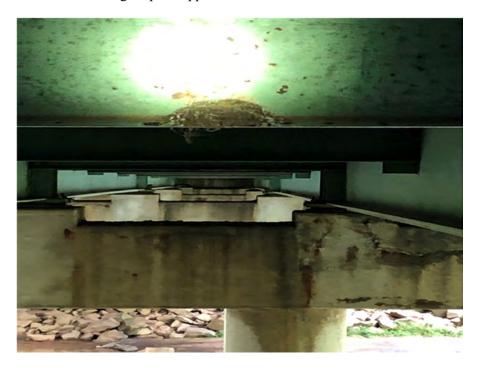
Photo 2: Bridge 1. View of pigeon nest on beam. Bird droppings present but no bat guano observed.

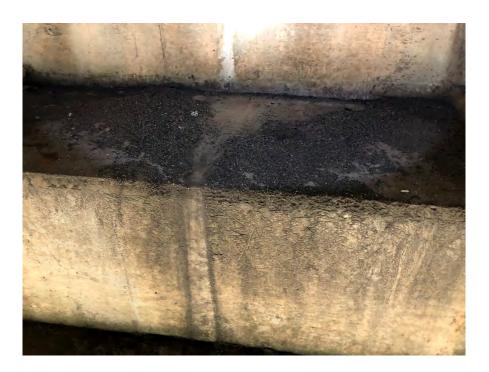
Photo 3: Bridge 1. View of water stains and accumulated sediment and gravel from road at the abutment. No bat guano was observed.

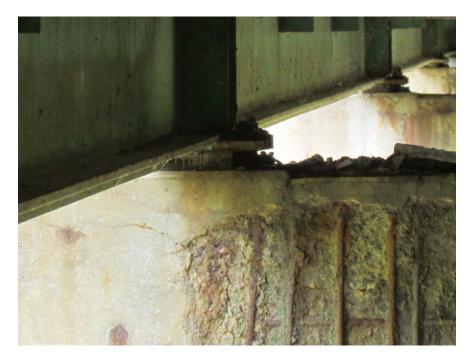
Photo 4: Bridge 1. View of concrete and debris accumulated on piers. Debris on beams from spider webs and bird droppings. No bat guano was observed.

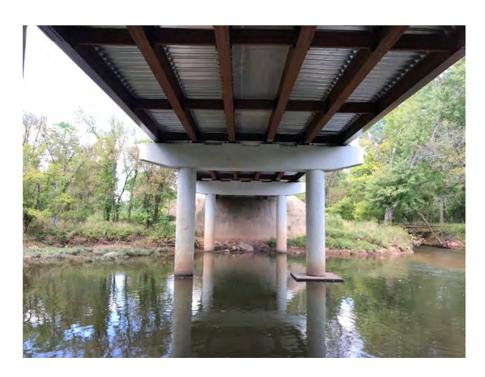
Photo 5: Bridge 2. View of bridge and piers crossing Bull Run. No visible staining or guano.

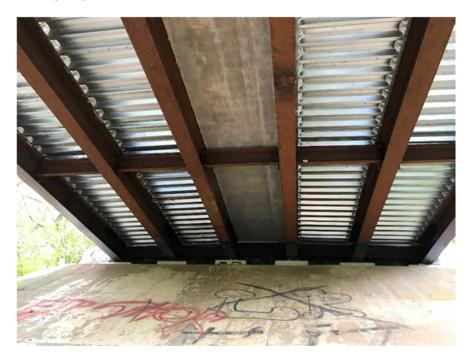
Photo 6: Bridge 2. View of abutment and steel decking. No visible staining or guano.

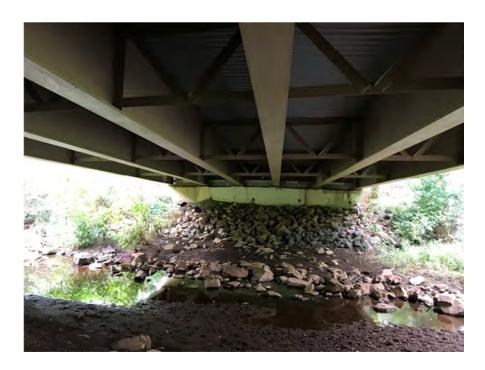
Photo 7: Bridge 3. View of low bridge spanning Flat Branch. No guano or staining observed. Several bird nests and droppings were observed.

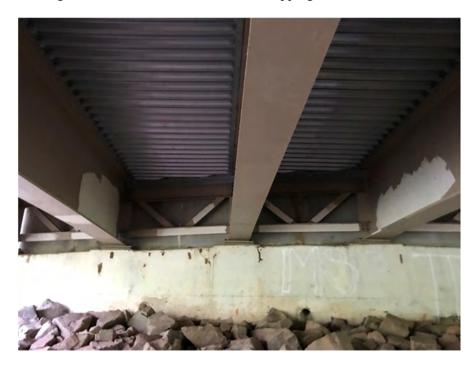
Photo 8: Bridge 3. View of abutment and steel beams and decking. No guano or staining observed. Scattered mouse droppings present.
